Report of Yacht Survey on the Vessel “ Searaz”

December 2, 2018

This is a report of the survey of the 1988, Porsuis Shipyard, Netherlands. Motor Yacht "Searaz". The survey was conducted on date. The survey was carried out while the vessel was in the water at D-Marin Didim Marina. The Owner's representative Fatih Mehmet Tuluay from Derin Boats Company was present during the survey. The Owner commissioned the survey. The purpose of the survey was to evaluate the vessel's condition and value prior to purchase.

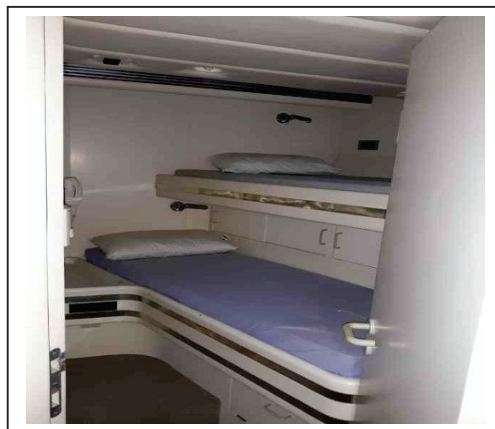
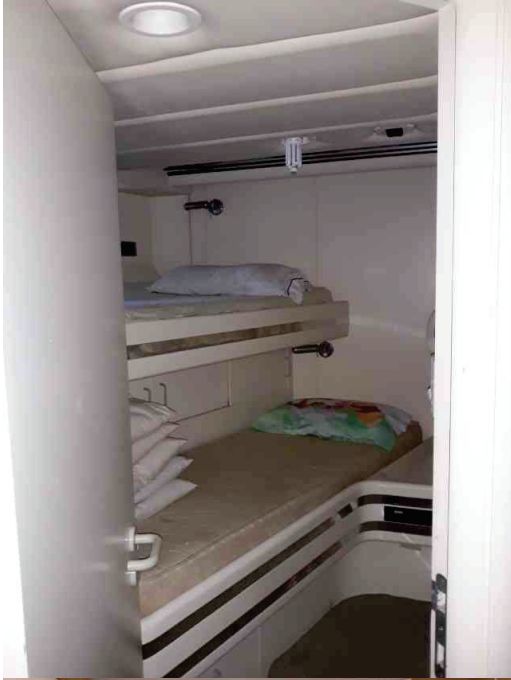
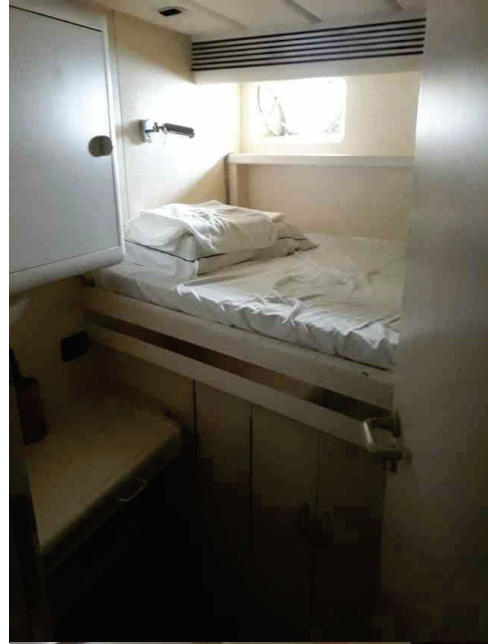
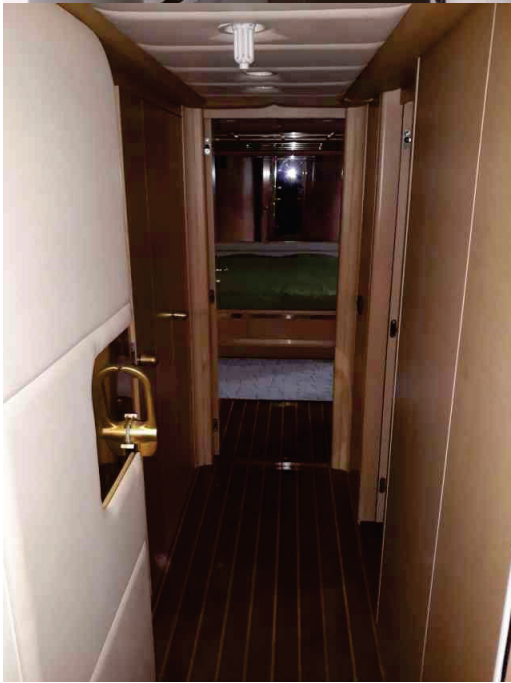
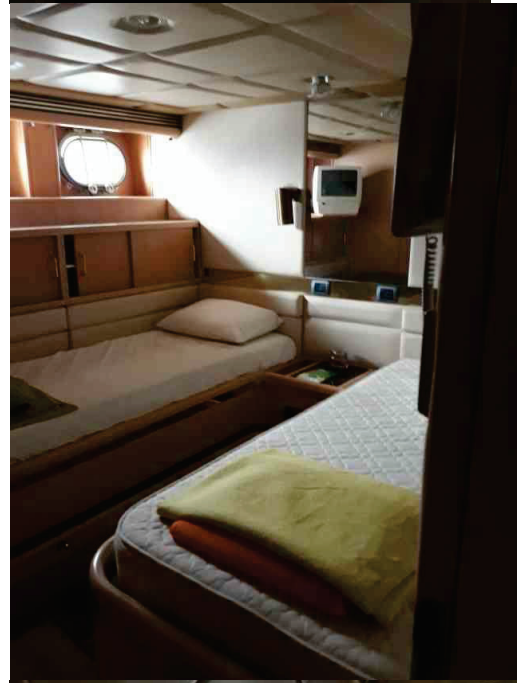
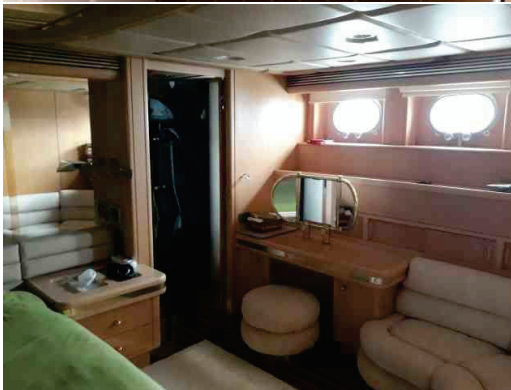
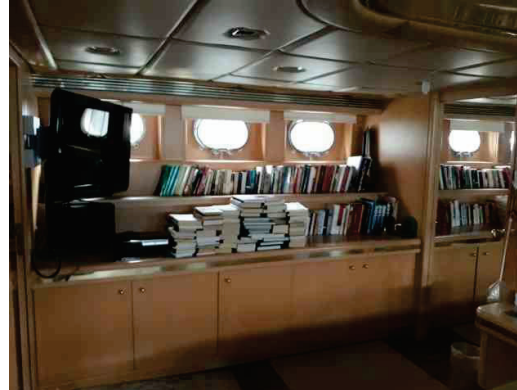
Saloon: No big structural defects were found in the saloon. Ceilings are made with plywood covered with beige cloth.

Cabins: There were 2 guest cabins, 2 master cabins, 1 captain, 2 personnel cabins.

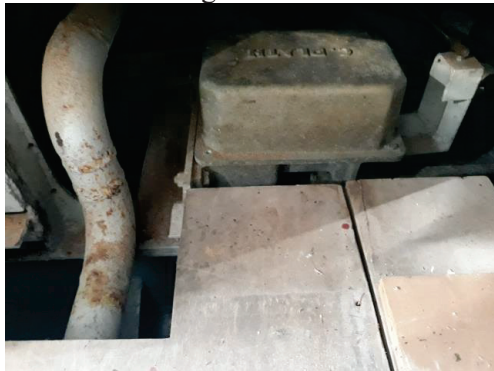
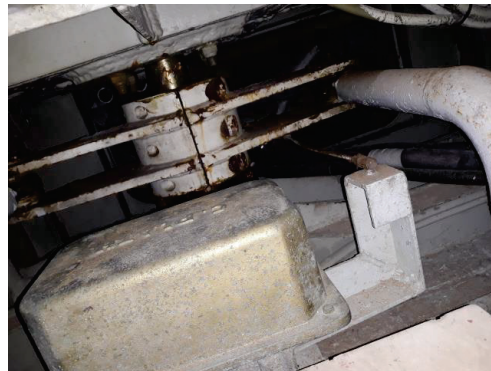
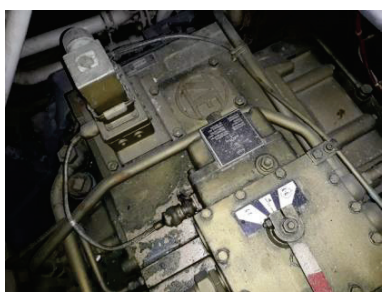
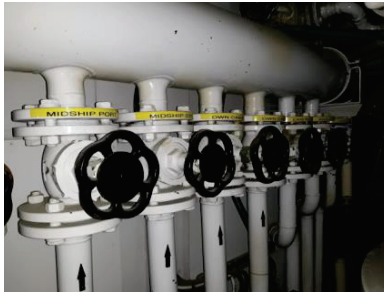
General: Twin MTU 12V 396 TB94 Diesel brand diesel inboards with shaft drives,

They looked to be in excellent condition from external examination. The bilge was covered with bilge floors and it was not checked.
